# Thuraya Orion IP

## Satellite Terminal User Guide

Revision 5  
3500869-0001

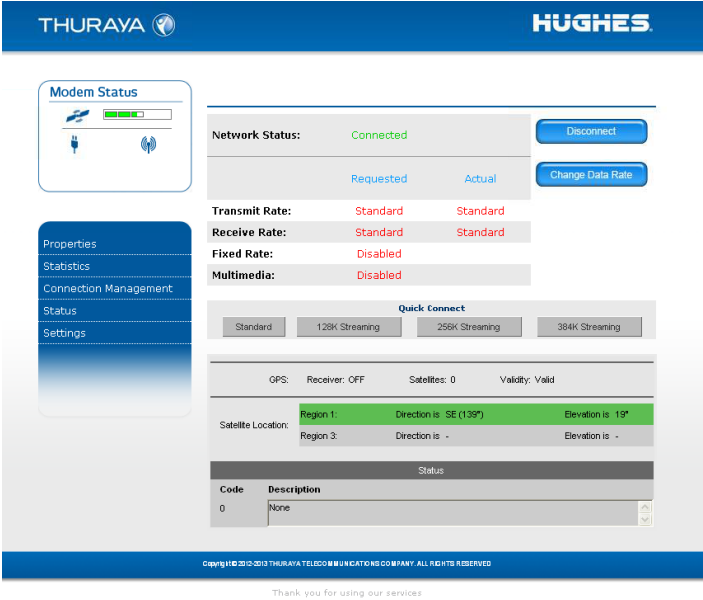
# HOME SCREEN

The **Home Screen** provides you with key summary status information about the Thuraya Orion IP and is also a gateway into Thuraya Orion IP management.

**GPS:** The display includes the GPS receiver state (On/Off), GPS satellites visible, GPS validity, compass direction and ADU angle. Once a GPS position is obtained, the Thuraya Orion IP will provide the compass direction and degrees of elevation to the satellite. This information can be used to ensure that the ADU has a clear view of the Thuraya satellite at the current location.

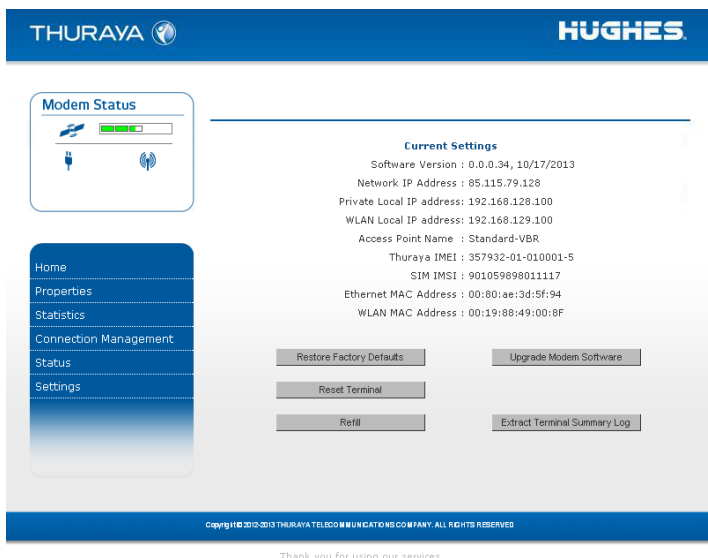
## PROPERTIES SCREEN

The **Properties Screen** displays a summary of current communications parameter settings. You can also use this screen to do the following:

**Restore Factory Defaults:** When you click this button, the **restore message confirmation screen** informs you that the terminal is about to reset to factory defaults. Restoring the factory defaults returns the Thuraya Orion IP settings to their original, just out-of-the-box state. This does not change the security code or SIM parameters. Please exercise caution when proceeding. If you invoke **Restore Factory Defaults**, you will need to re-enter any configuration information supplied by your Service Provider.

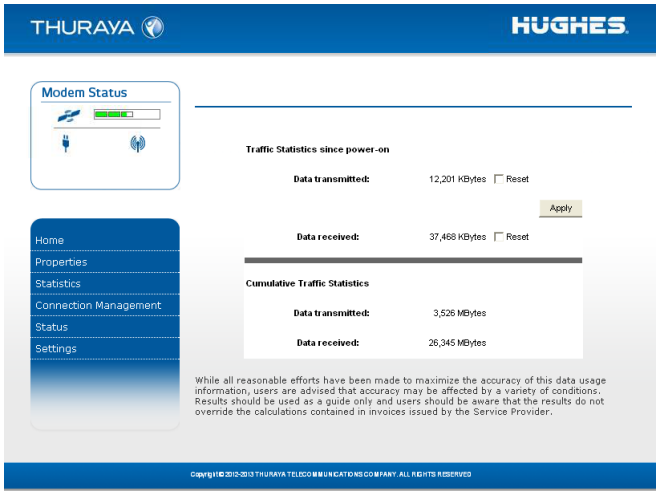
STATISTICS SCREEN

The **Statistics Screen** provides you with an estimate of your data usage. Data usage figures are obtained by counting the bytes in the IP packets received by and sent from the Thuraya Orion IP. You can view both “since power on” (per session) and “cumulative” (lifetime) data usage counts. To reset the data counters of a session, simply select the **reset** button for either transmit or receive and click the **Apply** button.

**Note:** The data usage figures provided on the screen are estimates only. This feature is not tied into the actual billing system. Hughes assumes no liability if differences are found between data usage figures and your actual bill.

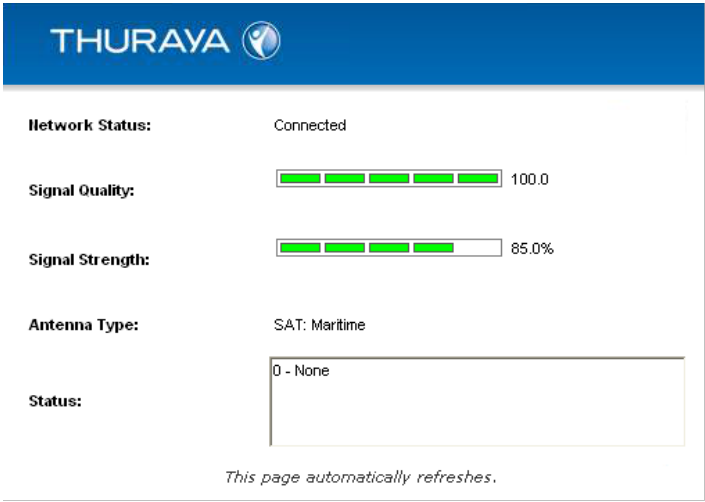
# STATUS SCREEN

The **Status Screen**, displayed in a separate window, provides you with a constantly updated flow of dynamic information and a concise summary of the Thuraya Orion IP status.

When the **Status Screen** is open, its information is updated every minute.

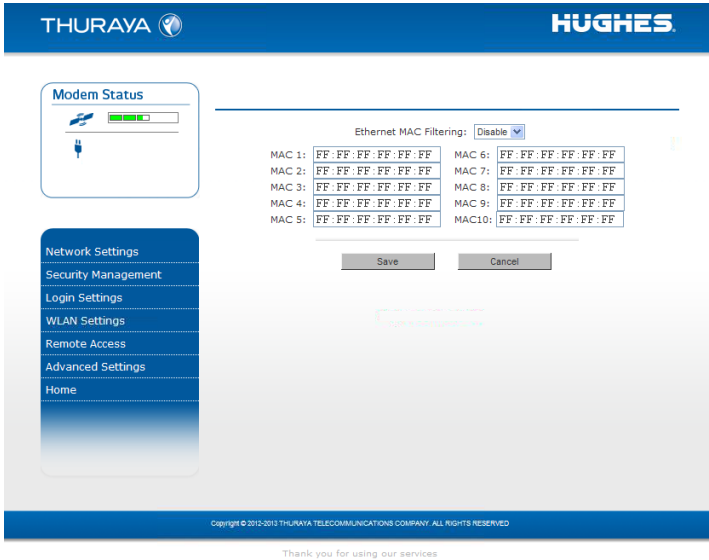
**ETHERNET MAC FILTERING CONFIGURATION SCREEN:**

From this screen you can enable and disable Ethernet MAC filtering and you can specify up to eight MAC addresses in the white list. Any

changes to this configuration screen will be effective upon a restart of the UT.

**Note:** Enabling MAC filtering without specifying any entries in the list will disable the Ethernet ports in favour of WiFi access only. Be sure to enable WiFi on the UT before disabling the Ethernet ports so that you do not lose access to the wMMI.

Ethernet MAC Filtering: Ethernet MAC filtering provides a means to restrict Ethernet access to the UT to devices that have their MAC addresses specified in the white list. To enable Ethernet MAC filtering, click on the Ethernet MAC Filtering Configuration link on the Security Management Screen. This will take you to the Ethernet MAC Filtering Configuration Screen.

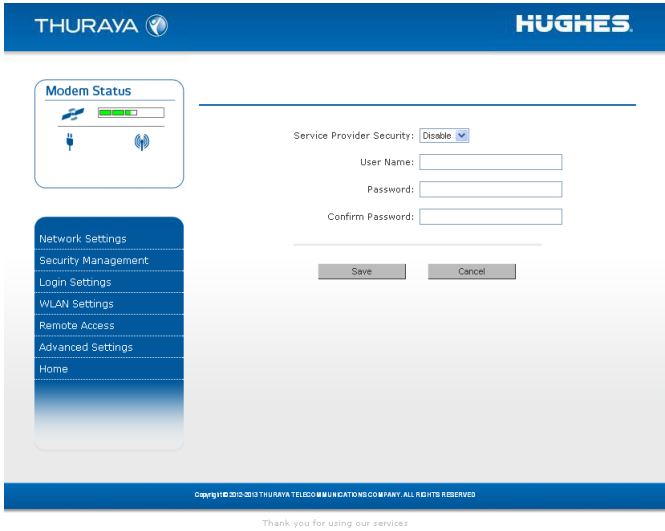
LOGIN SETTINGS SCREEN

Utilize the **Login Screen** only if you have been given the necessary information from your Service Provider.

Service Provider Security: If this is **enabled**, you can enter a **User Name** and **Password** for authentication between the Thuraya Orion IP and your Service Provider. Your Service Provider will let you know if this step is required and give you the necessary information.

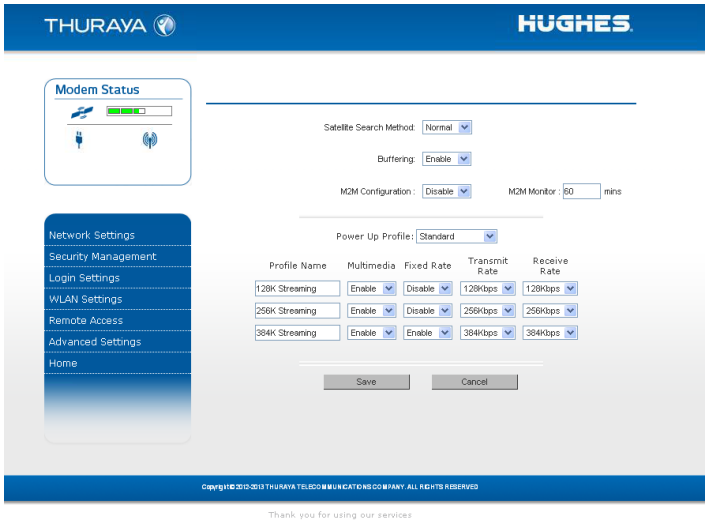
# ADVANCED SETTINGS SCREEN

The **Advanced Settings Screen** allows you to modify several key operating parameters in the unit.

Satellite Search Method: **Normal** is the default method to use unless your Service Provider specifies the Full Method. The **Full** method takes longer and utilizes more resources since it will search all possible frequencies for the Thuraya IP service. This full search can take up to 20 minutes.
